# CHANGES IN SURFACE TOPOGRAPHY AND MICROCOMPOSITION OF A PALLADIUM CATHODE CAUSED BY ELECTROLYSIS IN ACIDIFIED LIGHT WATER

## ABSTRACT

A thin palladium cathode became bent and torn during electrolysis in acidified light water. Localized changes in composition were observed, including the occurrence of chlorine and possibly silver. Transmutation by neutron absorption may have caused the formation of silver.

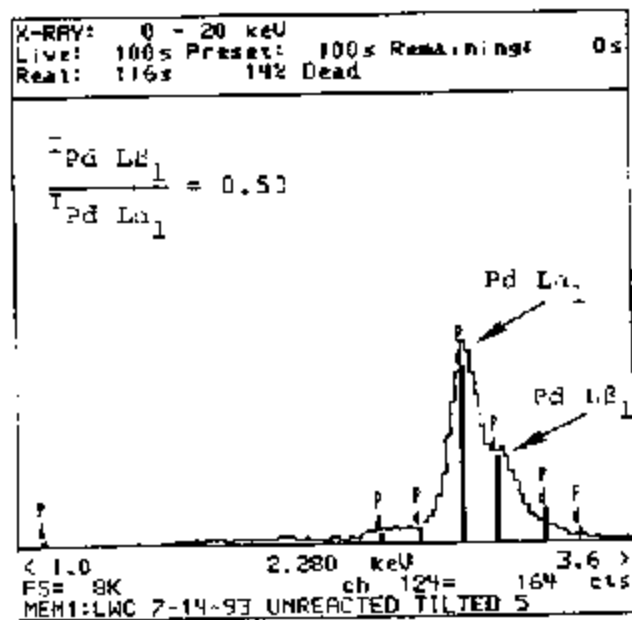
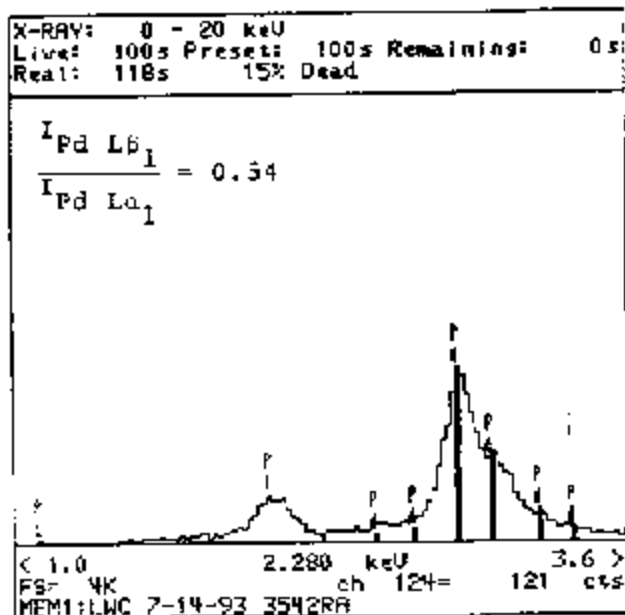
Fig. 2. EDS spectra from a palladium cathode after electrolysis in acidified light water. (a) Spectrum from the square area in Fig. 1a. The positions of Pd  $L\alpha_1$  and Pd  $L\beta_1$  are indicated. (b) Spectrum from the square area indicated in Fig. 1b. The ratio  $I_{Pd L\beta_1} / I_{Pd L\alpha_1}$  is indicated for each.

Using the EDS, spectra were taken from the square areas indicated on Fig. 1a and 1b, using identical experimental conditions. These are shown in Fig. 2. Superimposed on these spectra are vertical bars which indicate the positions and expected relative intensities of six palladium L peaks. The two most intense L peaks are  $L\alpha_1$  at 2.84 KeV with relative intensity 100% and  $L\beta_1$  at 2.99 KeV with relative intensity 42%. Actual relative intensity of  $L\beta_1$  to  $L\alpha_1$  in Fig. 2a is 50% and in Fig. 2b it is 54%. Similar results were obtained by analysis of the remainder of the electrode areas shown in Fig. 1a and 1b. Thus, the ratio of the Pd  $L\beta_1$  intensity to the Pd  $L\alpha_1$  intensity is slightly greater in the electrolyzed portion of the palladium cathode (Fig. 1b) than in the unelectrolyzed portion (Fig. 1a). Changes in this ratio can be caused by factors such as differences in absorption [4]. Overlap with emission lines from another element could also produce changes in this ratio. For example, silver  $L\alpha_1$ , the strongest silver L line [4], occurs at 2.98 KeV. If silver were present in the palladium, it would increase the intensity of Pd  $L\beta_1$  without appreciably changing the intensity of Pd  $L\alpha_1$ . Thus, the presence of silver would increase the ratio of Pd  $L\beta_1$  to Pd  $L\alpha_1$ .

The spectrum in Fig. 2b, which came from the electrolyzed portion of the palladium cathode, has a strong platinum peak. This results from slow dissolution of the platinum anode and subsequent electroplating of Pt on the palladium cathode. The platinum peak is not present in the Fig. 2a spectrum from unelectrolyzed palladium.

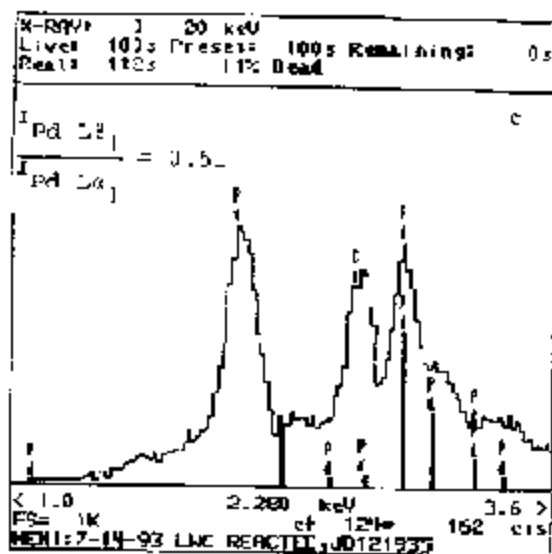
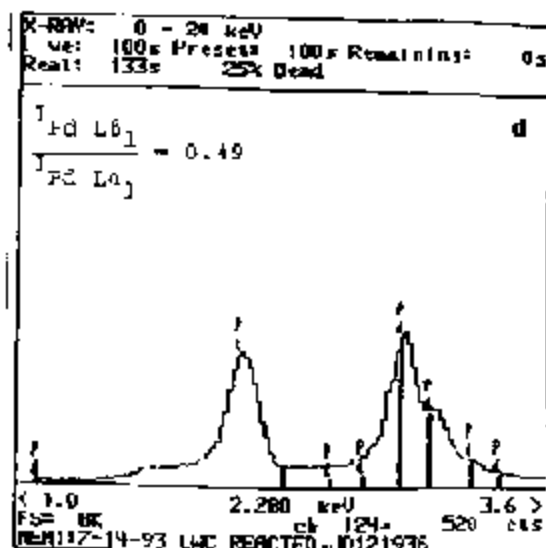
Fig. 3. (a) Enlargement of area near arrow in Fig. 1b. (b) Enlargement to show details of the protrusion near the center of Fig. 3a. (c) EDS spectrum from position 1 on the protrusion in Fig. 3b. (d) EDS spectrum from the square area shown on the lower right of Fig. 3d.

The arrow at the bottom left of Fig. 1b indicates an area which is enlarged in Fig. 3a, and enlarged further in Fig. 3b. An EDS spectrum from the feature which protrudes from the surface in Fig. 3b is shown in Fig. 3c. An EDS spectrum from the square area indicated in the lower right-hand corner of Fig. 3b is shown in Fig. 3d.

The protruding feature shown in Fig. 3a and in more detail in Fig. 3b appears to have erupted out of the surface of the palladium cathode. The surroundings are smooth and flat. The protrusion also differs in composition from the surroundings, as indicated by the intense chlorine peak between the platinum and palladium peaks in Fig. 3c and the absence of this peak in Fig. 3d. There is also a weak potassium peak to the right of the palladium peak in the spectrum of the protrusion, but there is no potassium peak in the spectrum from the right of the protrusion (Fig. 3d).

Three more spectra were taken from other positions on the protrusion in addition to that shown in Fig. 3b. Although the relative intensities differed from one position to another, the same elements (Pt, Cl, Pd, and K) were detected in all four spectra.

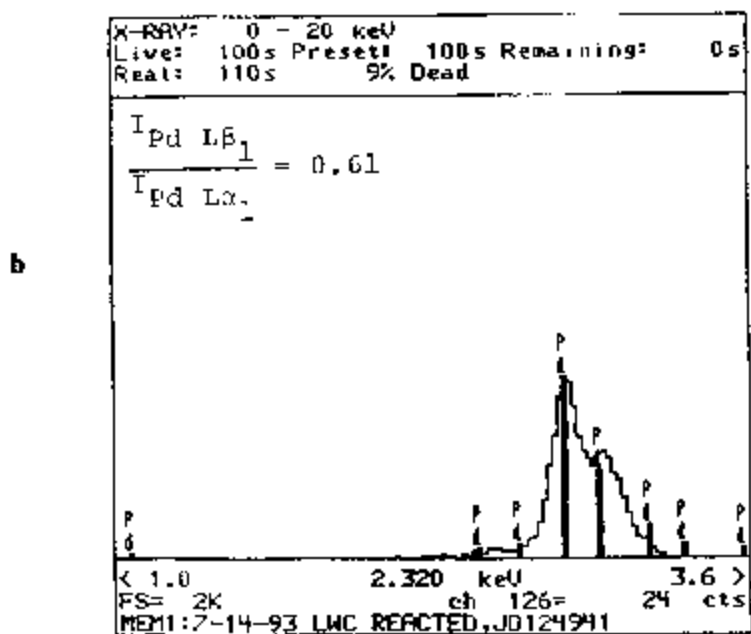
Fig. 4. (a) Enlargement of lower edge of palladium cathode to show changes in surface topography. (b) EDS spectrum from spot shown in Fig. 4a. Note that there is no platinum peak in this spectrum.

At about 50 $\mu$ m from the lower edge of the palladium cathode shown in Fig. 3a, the surface topography changes from uniform gray to a dark, mottled appearance, as shown in Fig. 4a. A spectrum from the spot indicated on Fig. 4a is shown in Fig. 4b. This shows the presence of palladium, but there is no peak for platinum such as that in Fig. 3d which was obtained from the uniform gray area on the lower right of Fig. 3b. In the spectrum of Fig. 4b the ratio of Pd  $L\beta_1$  to Pd  $L\alpha_1$  is 0.61, or about 0.1 greater than this ratio in all of the spectra shown above, from either the unelectrolyzed or the electrolyzed portions of the palladium cathode.

The upper portion of Fig. 4a has a fairly uniform, light gray appearance, similar to the region on the lower right of Fig. 3b which contains a large amount of platinum (Fig. 3d). It may be that the platinum peeled off of the lower edge during ultrasonic cleaning of the electrode. The current density was highest at the lower edge, and the electroplated platinum may have been dendritic and loosely adherent.

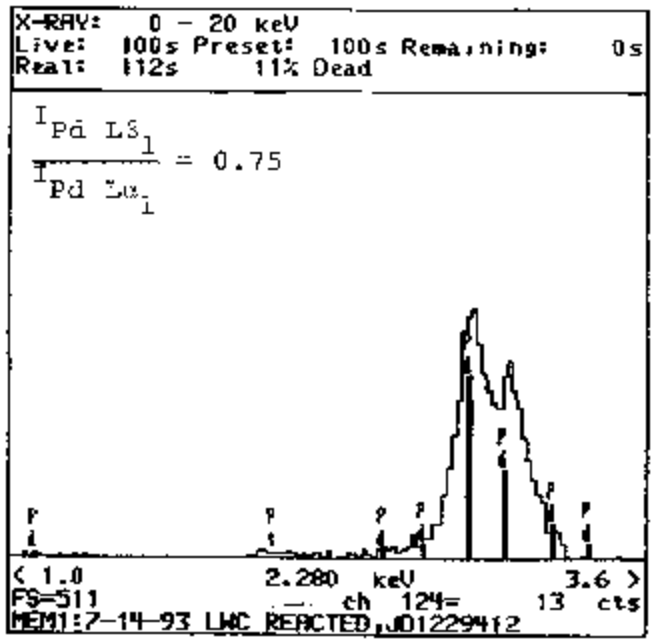
Fig. 5. (a) Enlargement of area a few microns from the lower edge of the Pd cathode. (b) EDS spectrum from square area indicated on Fig. 5a. Note that there is no platinum peak.

The mottled structure near the lower edge of the electrode in Fig. 4a is shown at higher magnification in Fig. 5a. The contrast in this photograph is most likely due to topographic differences. Light gray areas are probably higher in elevation than the interspersed dark, sub-micron diameter areas.

The composition of the area within the square indicated above the center in Fig. 5a is given by the spectrum in Fig. 5b. This is similar to the spectrum in Fig. 4b in that platinum is not present. The ratio of the palladium  $L\beta_1$  peak height to the  $L\alpha_1$  peak height is 0.75, which is 0.15 greater than the same ratio in Fig. 4b and about 0.25 greater than this ratio in all the spectra taken at distances more than  $50\mu\text{m}$  above the lower edge of the cathode.
